**BARTON WASTEWATER  
POST JULY 2023 FLOOD  
TREATMENT PLANT ASSESSMENT  
ORLEANS COUNTY, VERMONT**

**NPDES PERMIT NUMBER VT0100641  
STATE OF VERMONT PERMIT NUMBER 3-1202**

**October 09, 2023**

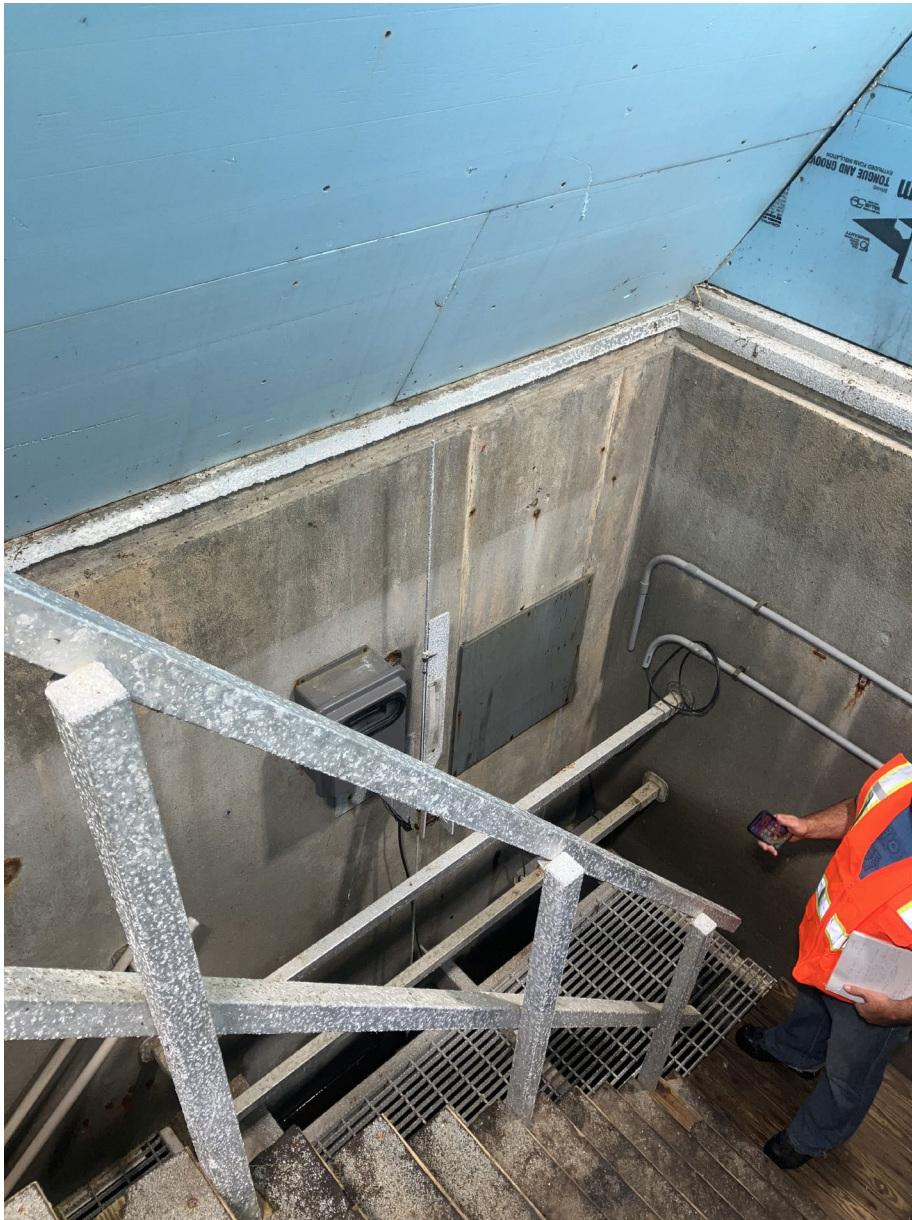
At the time of the assessment, the plant appeared to be fully operational. The plant did not flood but heavy flows lead to Lagoon 1 overflowing into the effluent outfall building which caused the water level to rise above and damage the flow meter. A new flow meter was purchased, installed, and elevated to above grade so flows could be measured prior to the assessment. Water backed up from the outfall building into the filter room, likely through the chemical feed conduit, but floor drains captured all water and there was no apparent damage.

1- Old Flow Meter (Note Flood Water Line Was 12 Inches Above Meter as Depicted by the Lighter Gray Line on Wall)

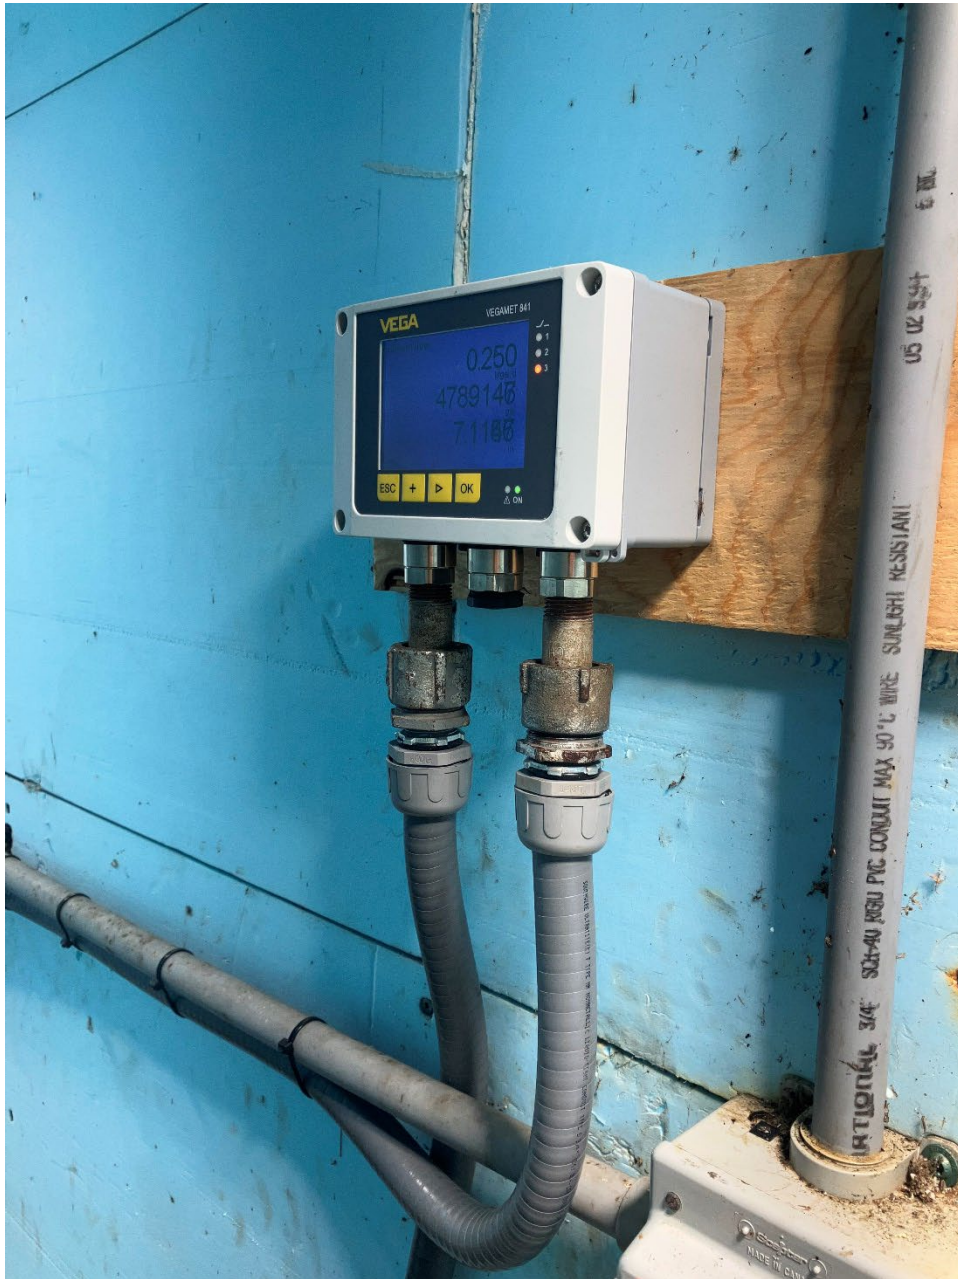
*2- New Flow Meter Elevated to Above Grade Just Inside the Doorway of the Outfall Building*

- The plant will need to do a full calibration of the new flow meter since the meter gauge was damaged.
- The grit pump will need to be repaired/replaced.
- Evaluate and rebuild or replace all pump station pumps for future efficiency.
- In order to prevent water from backing up into the filter room, the facility should remove and relocate the chemical feed lines and piping from the effluent room that runs to that area. The internal piping of those lines allows high effluent water to back up into the filter room.
- Bulk chemical (sodium hypochlorite and metabisulfite) storage should be moved to a new outbuilding adjacent to the effluent room.

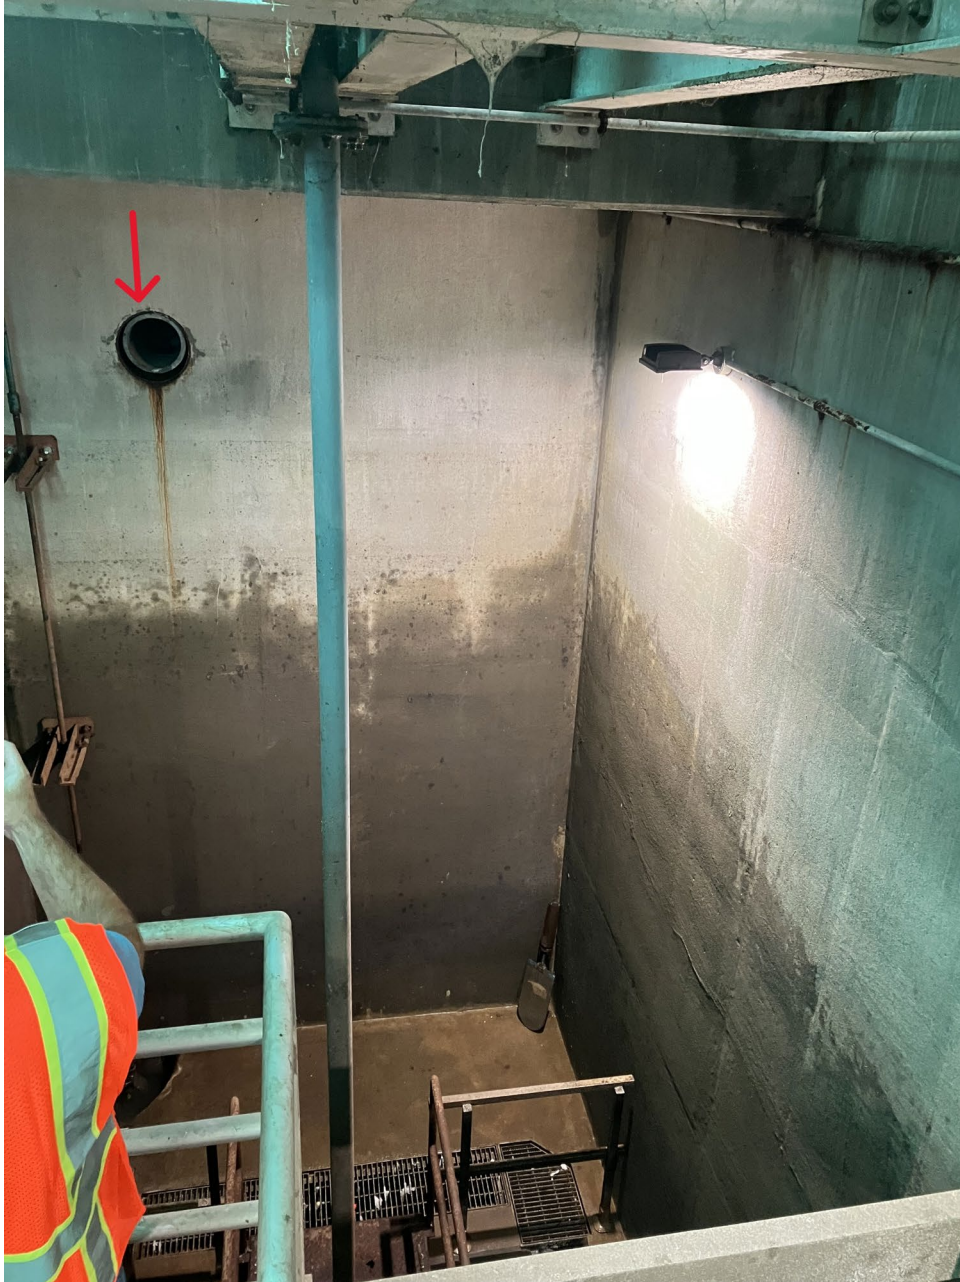
Excessive flows into the pump station caused the water level to rise and overflow raw wastewater via the overflow pipe into the river. It is expected that pump station pumps will need to be rebuilt or replaced due to heavy silt and grit in valves that will cause premature wear over time. The grit pump was pumping large amounts of grit and will likely need to be rebuilt/replaced.

*3- Main Pump Station Overflow Pipe Noted*

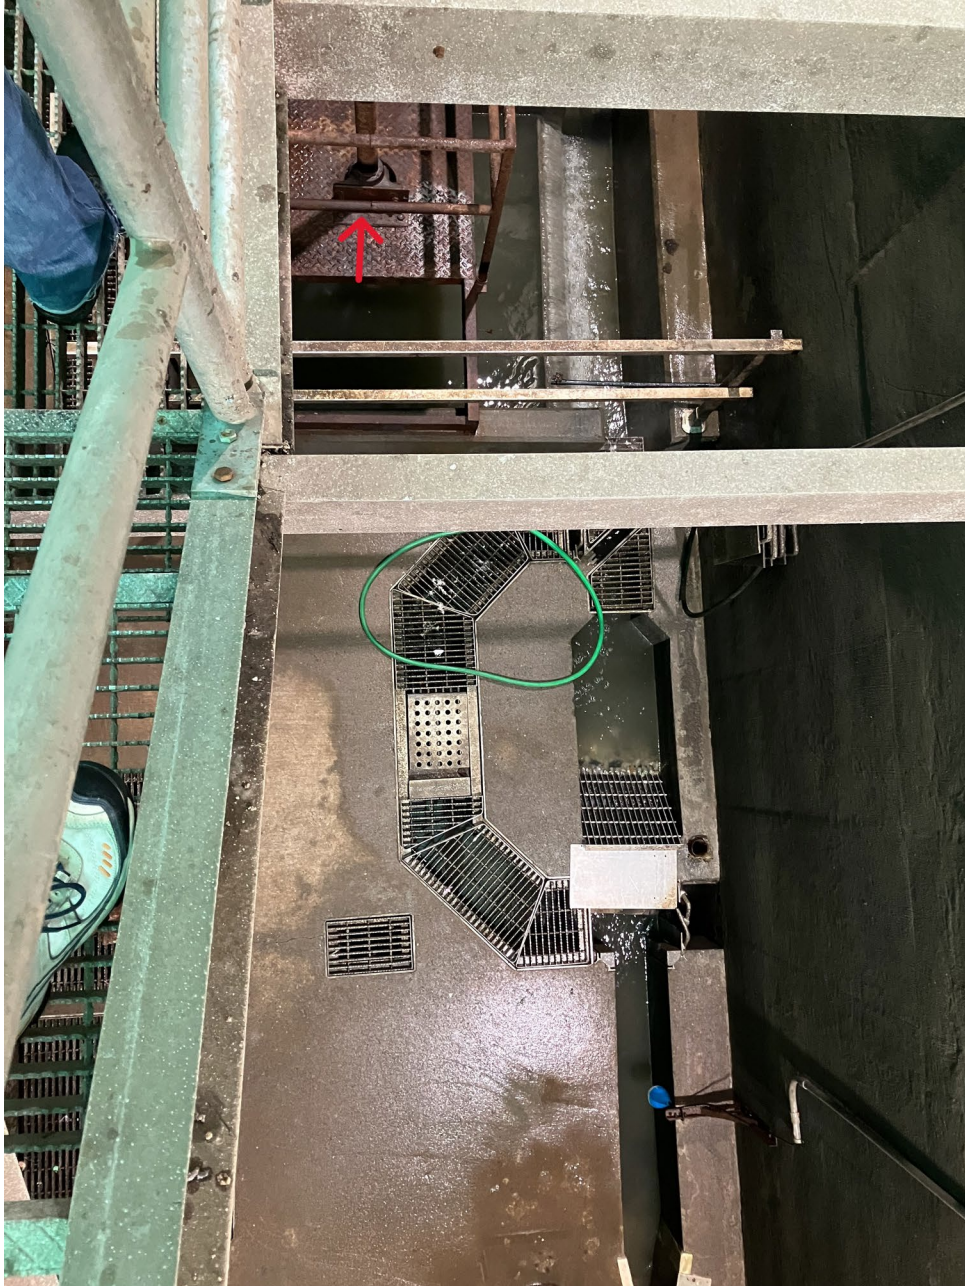
4- Grit pump in Main Pump Station

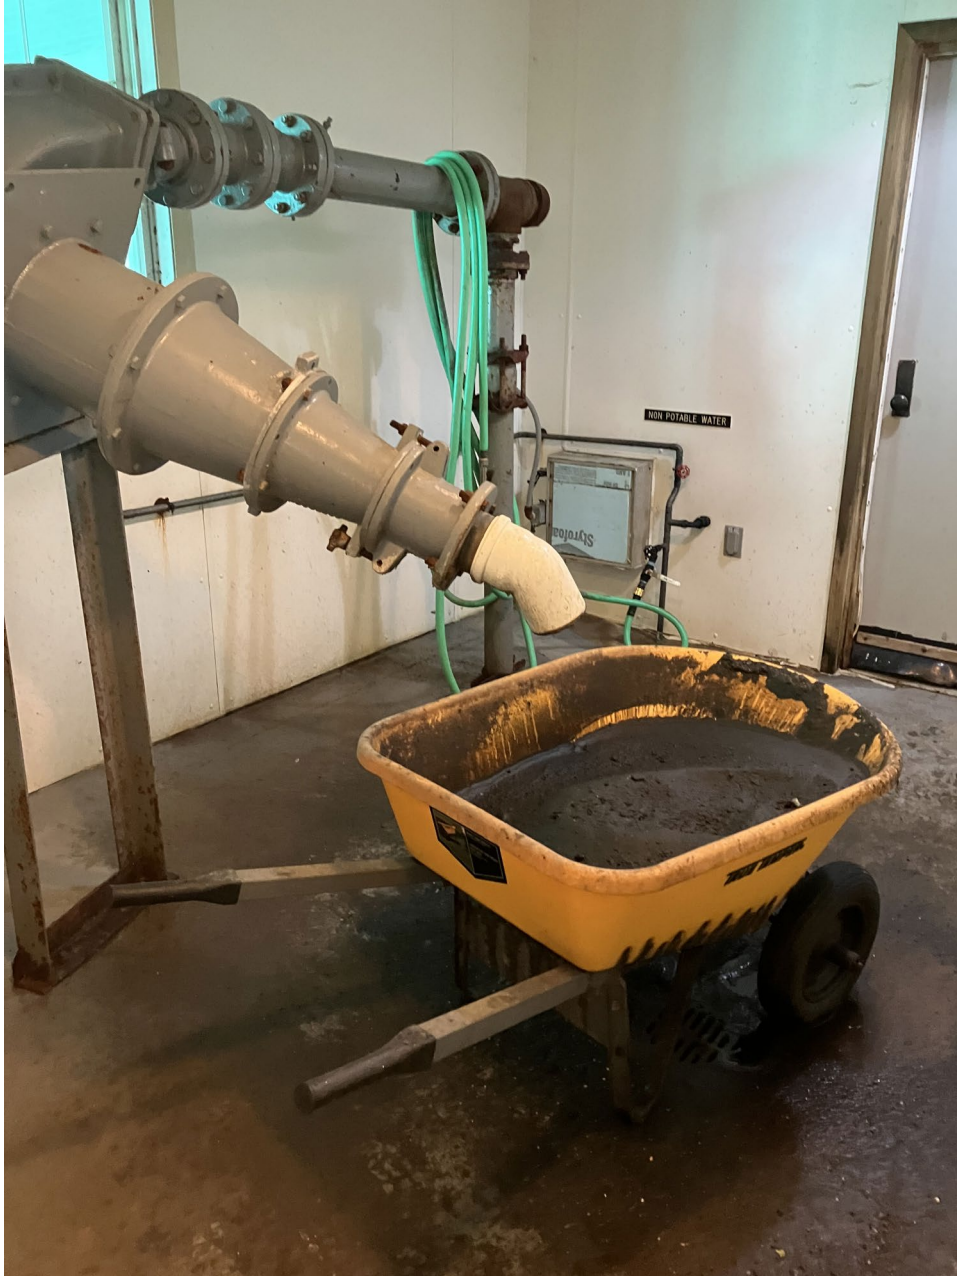
*5- Excessive Grit from Grit Pump in Main Pump Station*

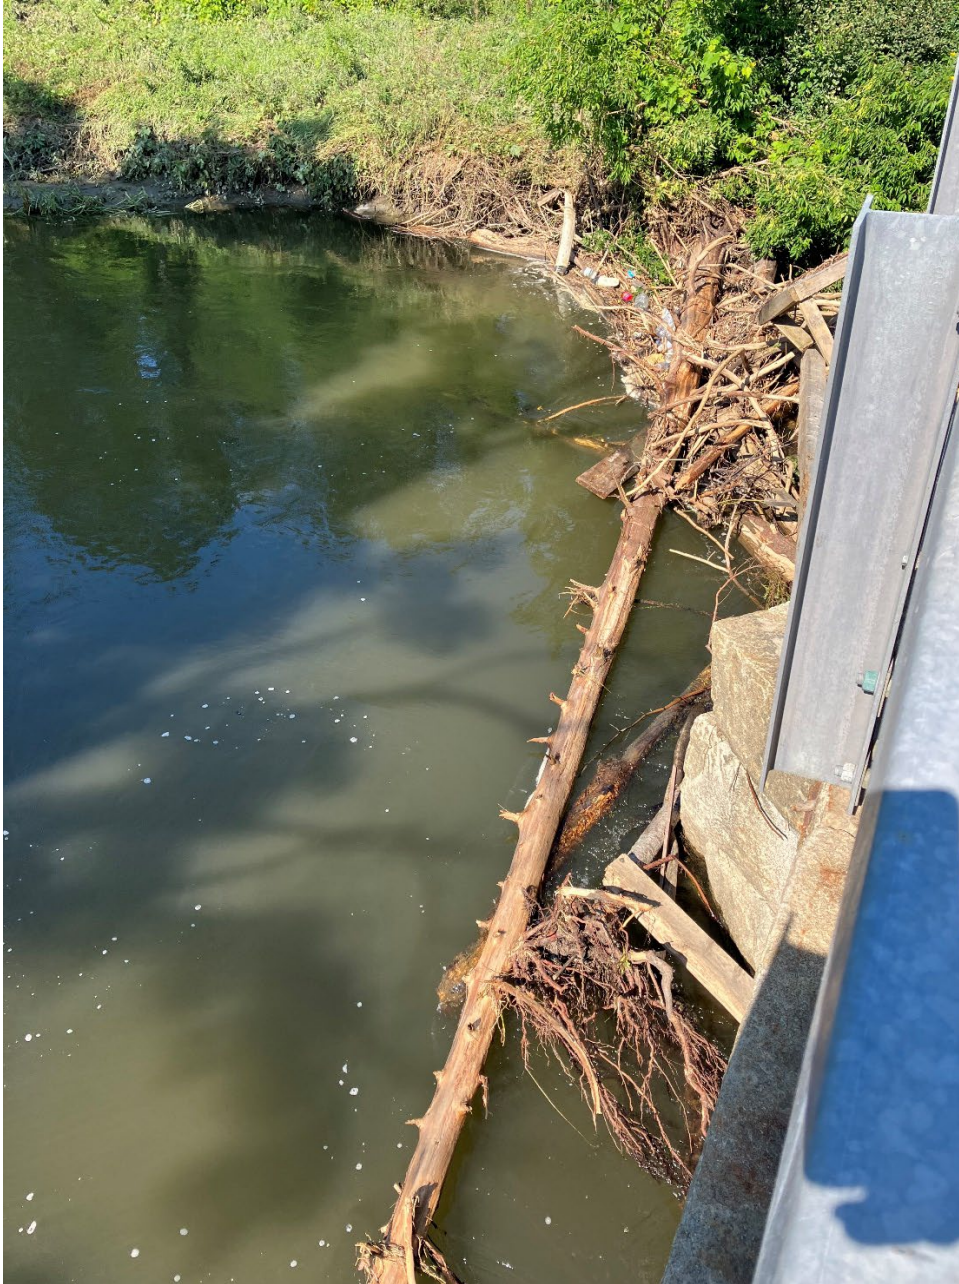
The operator expressed concern that there may be breaks in some lines that are allowing excess inflow/infiltration including a sewer line that runs under the river that is possibly damaged. Overall, the collection system received large amounts of grit/silt/debris.

*5- Bridge Above Submerged Sewer Line Under the River. Manholes are Located on Both Sides of the River*

- Jetting and camera inspection of low-lying collection system areas as the collection system received an appreciable amount of grit/silt/debris. Camera inspections should be explored to ascertain collection system damages.
- A leak or smoke test should be performed of the river crossing sewer line since it appears there is excessive flow (inflow/infiltration) entering the sewer line from the river.
