**ORLEANS WASTEWATER  
POST JULY 2023 FLOOD  
TREATMENT PLANT ASSESSMENT  
ORLEANS COUNTY, VERMONT**

**NPDES PERMIT NUMBER VT0100251  
STATE OF VERMONT PERMIT NUMBER 3-1201**

**October 3, 2023**

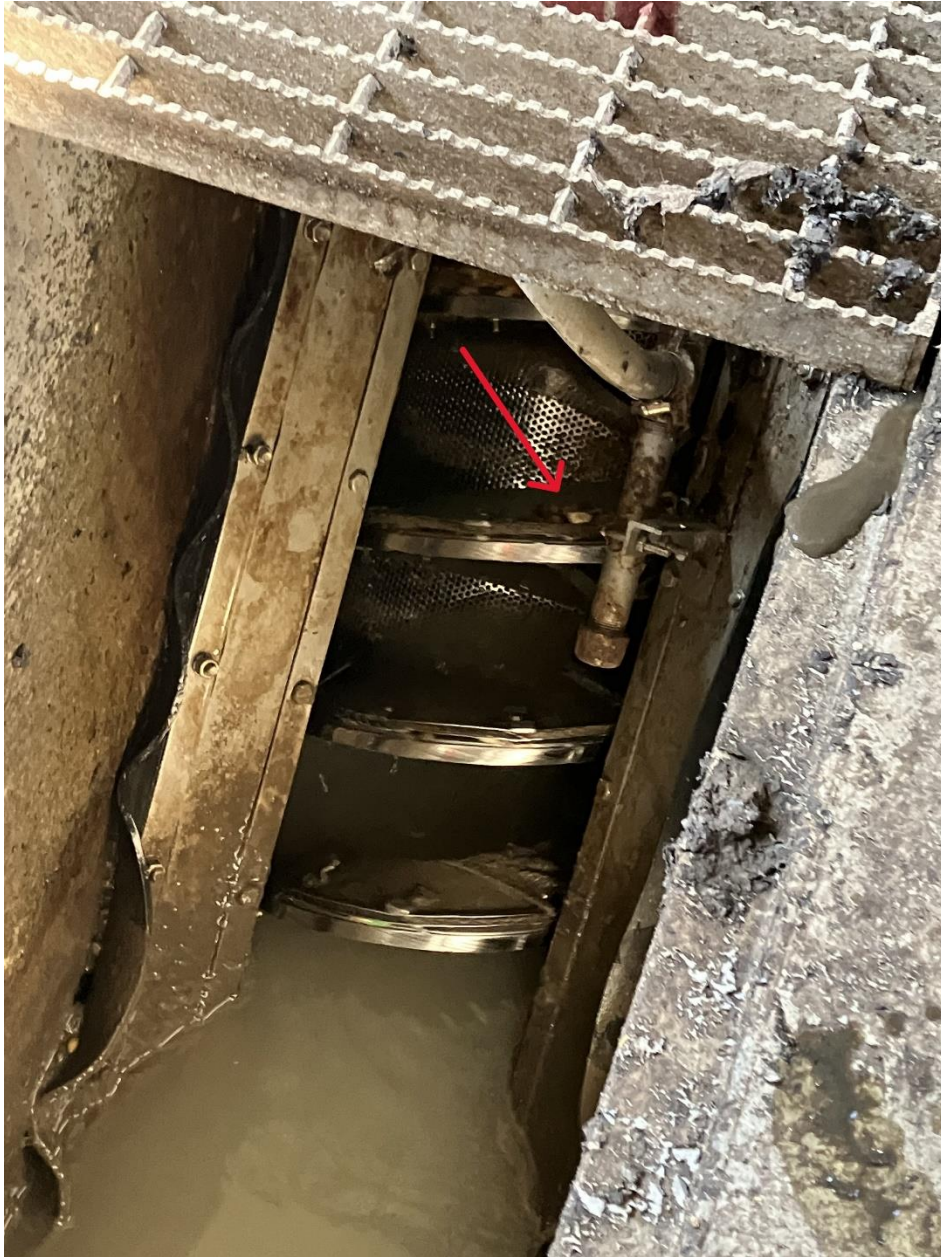
**Headworks:** The headworks received a large amount of gravel, grit and debris. The Lakeside fine screen auger pump was damaged due to pumping the gravel, grit, and debris.

*1- Lakeside Fine Screen Auger with Residual Gravel Noted*

- The Lakeside fine screen auger pump needs to be repaired/replaced.
- The facility will need to drain all treatment tanks to remove silt, sand, and grit.
- The plant will need to do a full calibration of the new flow meter since the meter

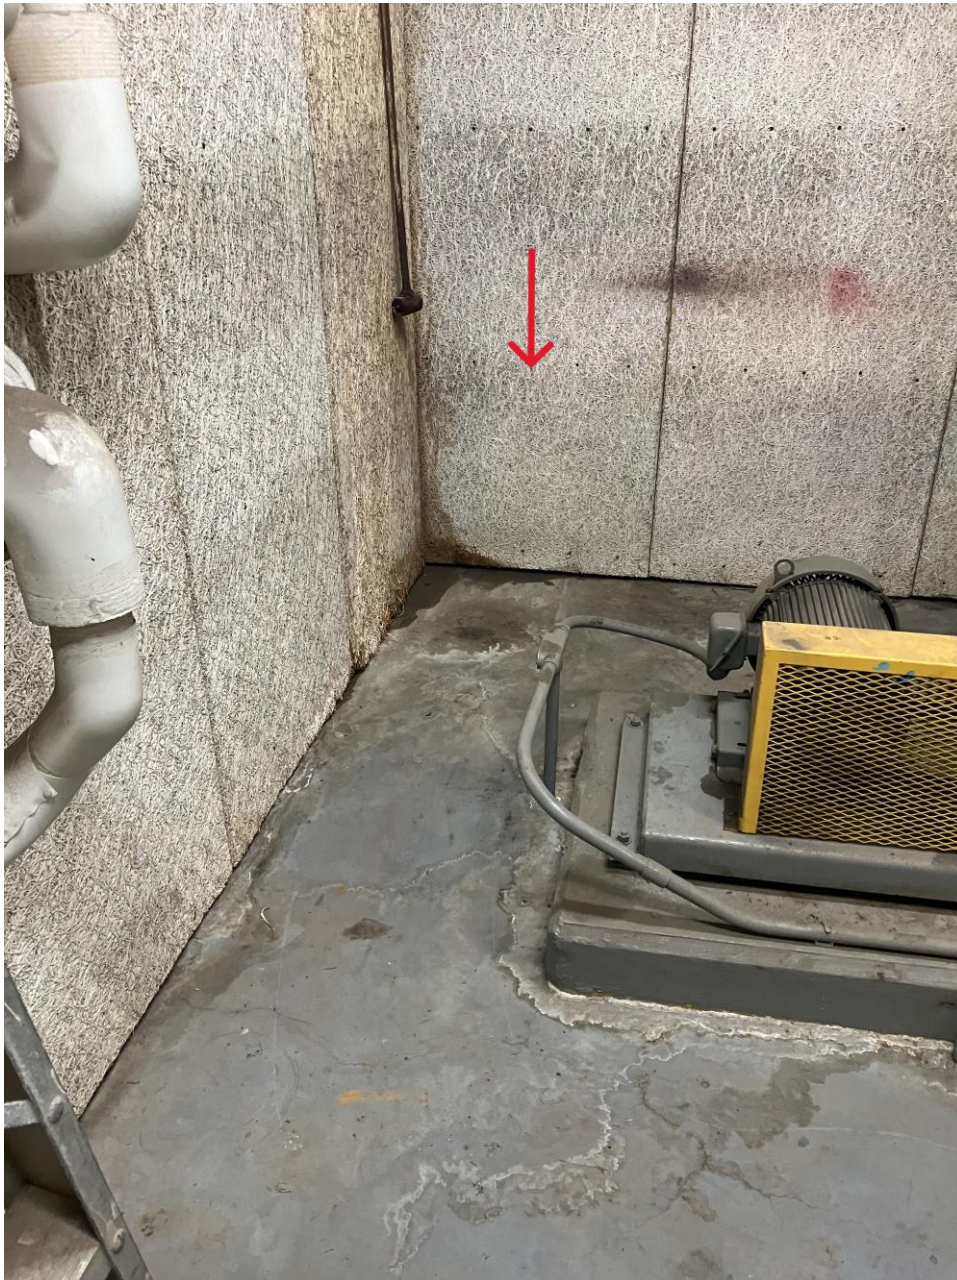
**Main Building:** Two feet of flood water entered the basement of the main building that houses the blower room where four Crown Triton Hyundai blowers and motors were damaged. The basement also houses the plant boiler. The Smith boiler supplies heat and hot water and is expected to be damaged although it has not been turned on given the hot summer months.

*3- Blower Room Showing High Water Mark at Approximately 2 Feet*

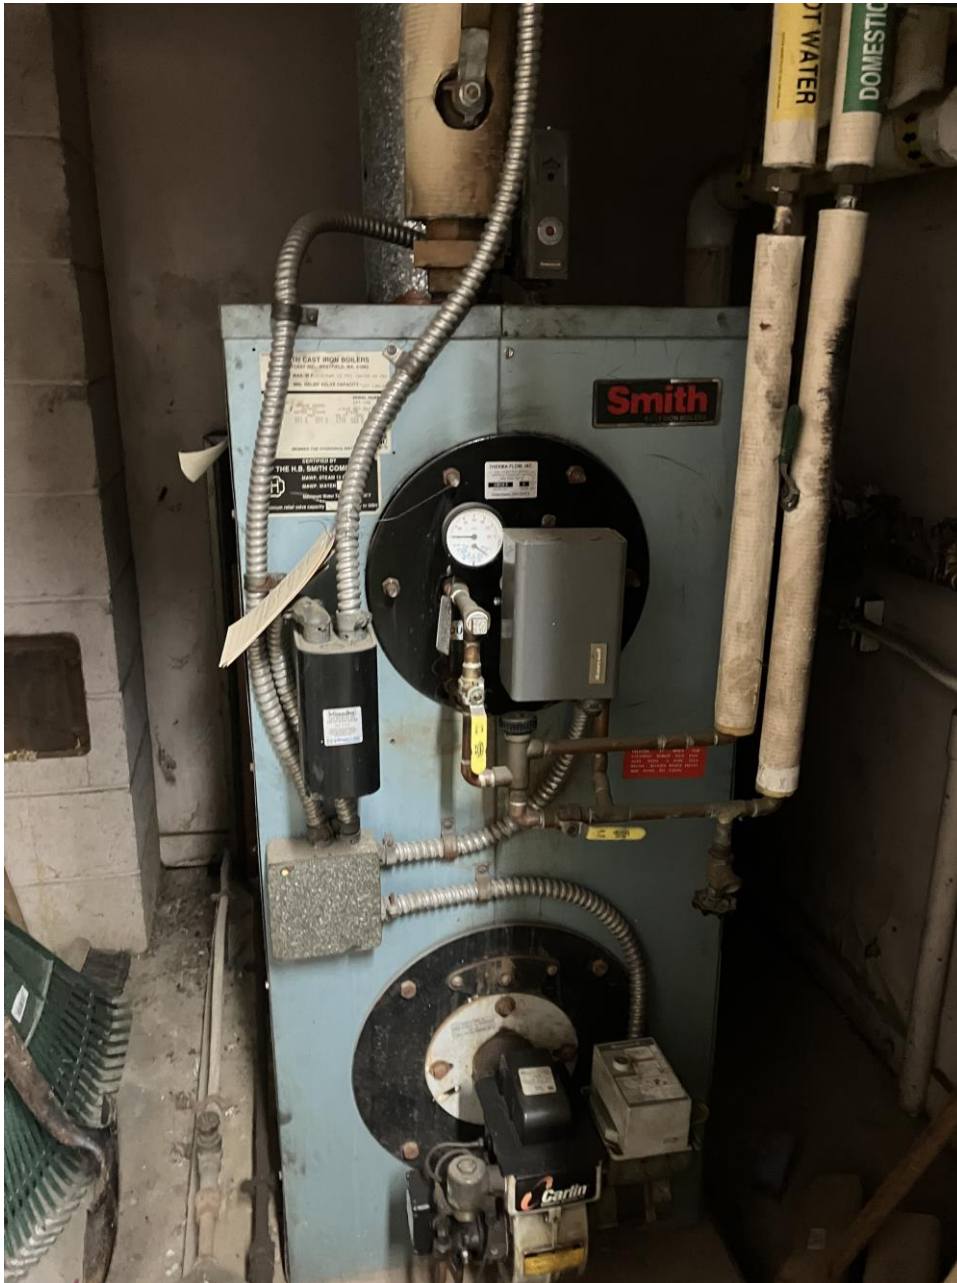
*4- Smith Boiler in Basement of Main Building*

- The Crown Triton Hyundai blowers need to be professionally evaluated for damage and subsequent repair/replacement.
- The plant's boiler needs to be evaluated for damage and subsequent repair/replacement.

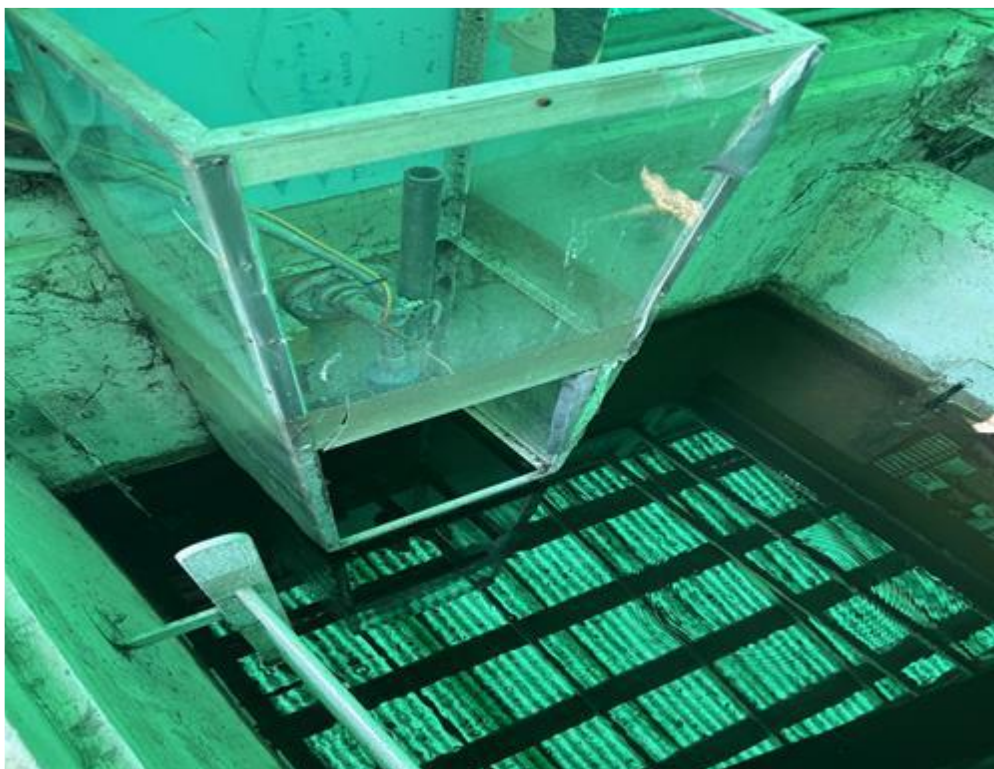
**Effluent Building:** Heavy flows from the river backed up through the effluent pipe into the effluent outbuilding. As a result, the flow meter gauge (picture #1) was damaged, and all electrical components will need to be replaced due to corrosion. Temporary power had been restored to the area.

6- Effluent Flow Metering Guage and Wiring (Photo Courtesy of US EPA Region 1)

- The facility should install a back flow preventer or duckbill on the effluent pipe to the river to prevent the back up of river water from entering the facility.
- Consider relocating the flow meter within the main building.
- Controls for pump stations should be elevated above flood stage.
- High flows may exceed the working capacity of chemical pumps. Additional pumps should be provided to deliver process and disinfection chemicals during high flows. Larger day tanks and supplies of chemicals on hand may be needed.
- Consider portable or fixed pumps to discharge effluent if gravity flow is no longer possible.

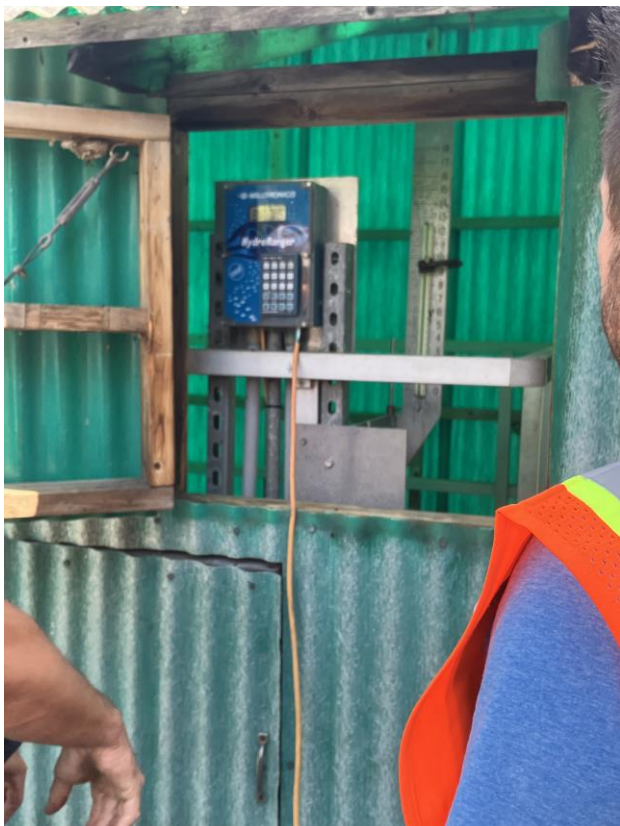
7- New Flow Meter with Temporary Wiring

gauge was damaged.
